An Experimental Investigation of the Chopping of Helicopter Main Rotor Tip Vortices by the Tail Rotor, Part II: High Speed Photographic Study

Contract NAS2-12256
September 1987

**Charles M. Cary
BBN Laboratories Incorporated
Cambridge, Massachusetts 02238**

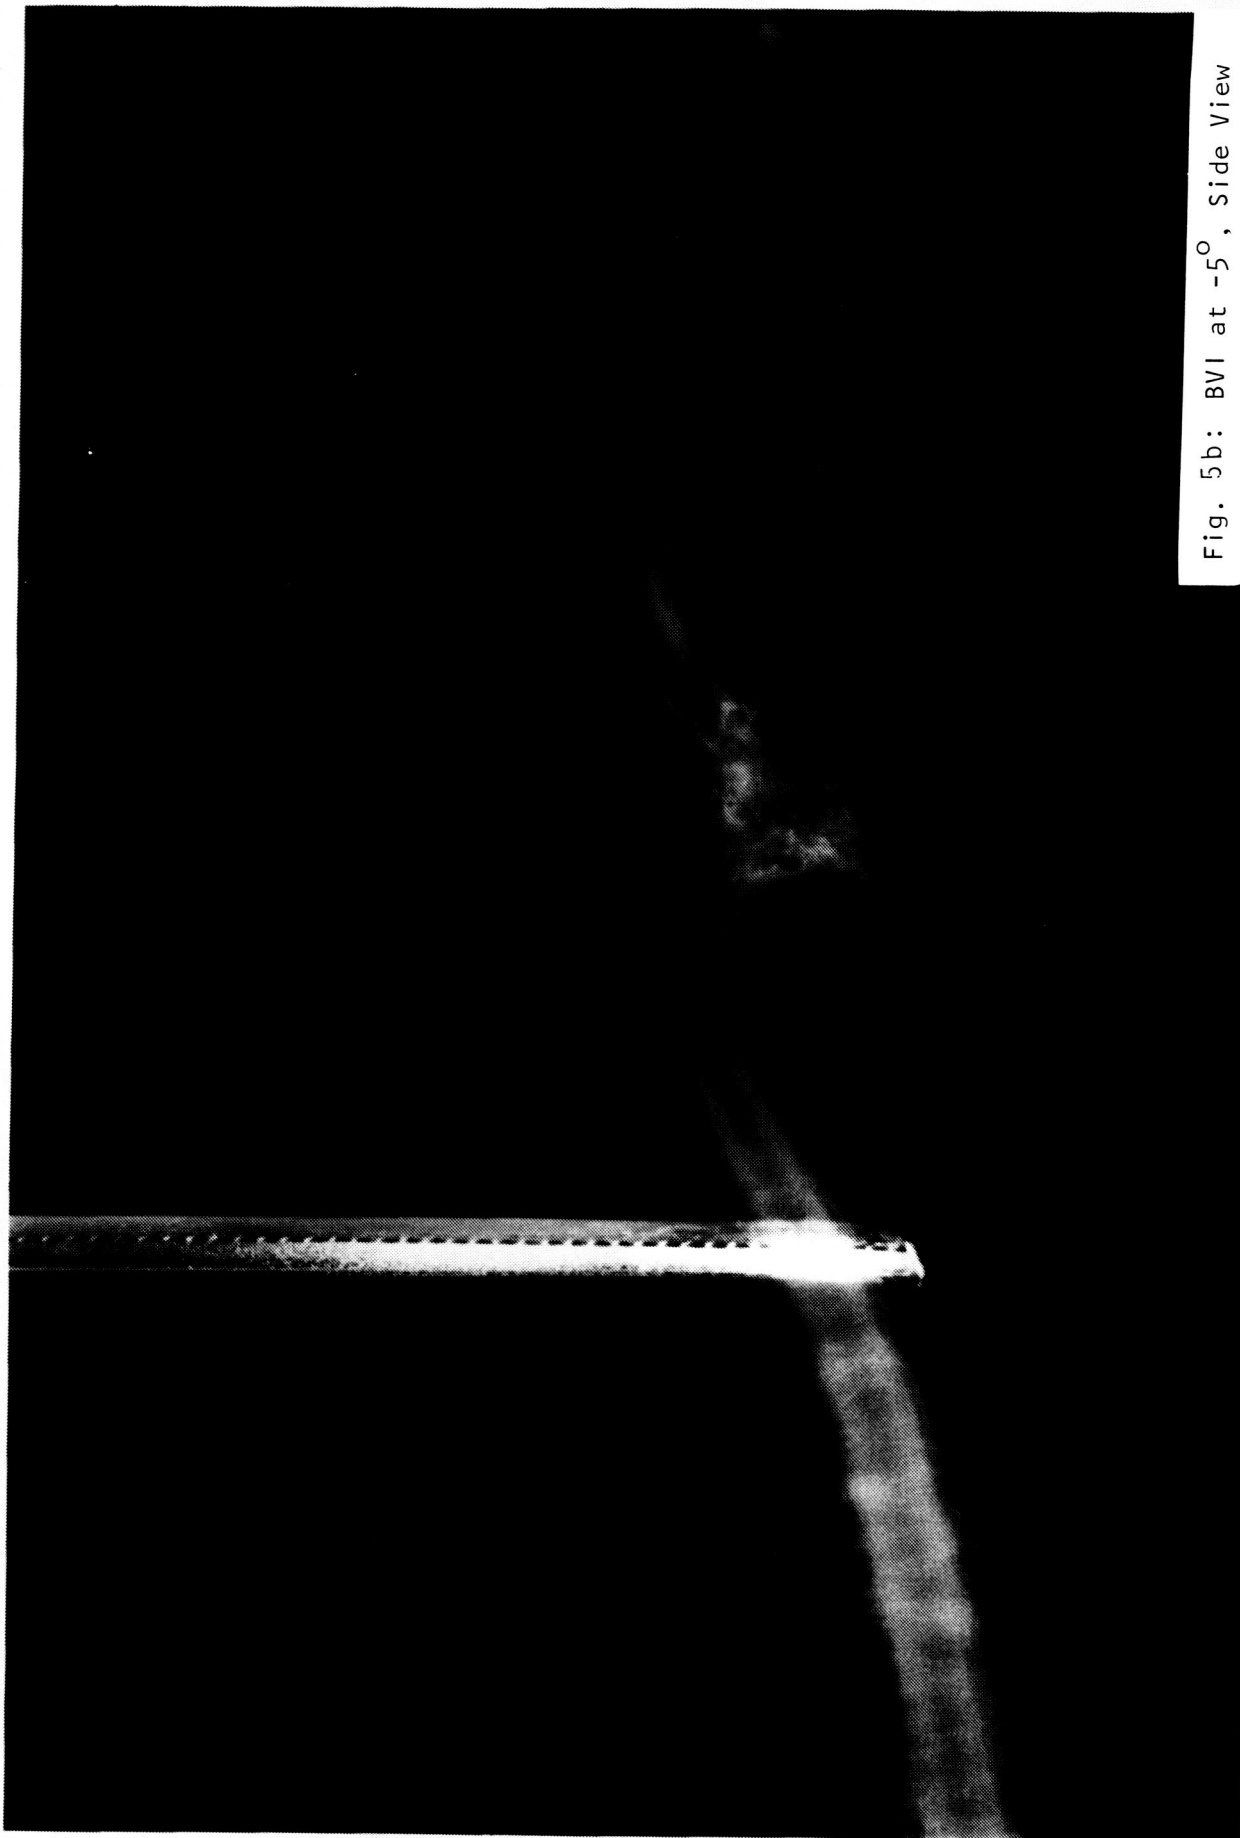
Fig. 5b: BVI at -5° , Side View

The set of photographs taken from the side is shown in Figs. 5a through 5k. The camera was in the rotor plane and approximately perpendicular to the leading edge at the instant of chopping. The camera position did not change and subsequent photoprocessing was indexed to the film sprocket holes, so that the position of the BVI has no motion component due to recording, processing, or reporting of the data. The 25.4 mm (1.00 in.) grid in Fig. 5a may be overlaid to show the motion of the incident vortex as it is chopped by the blade as it comes under the influence of the rotor tip vortex system. In the sequence

In this view the blade is viewed end-on at the instant of interception. Visualization of the blade vortex interaction for this view is shown in Figs. 5a through 5k. The blade is at -5° , 0° , 5° , 10° , 15° , 20° , 30° , 60° , 90° , and 120° sequentially with respect to the instant of vortex chopping.

Clearly the rotor tip vortex system causes large scale distortion of the incident vortex. The resulting wind-up is essentially perpendicular to the tip vortex and therefore plainly visible in the side view, while not at all visible in the bottom view. There is a separated wake at $r/R = 0.9$ which shows up in the bottom view but is hidden in the side view. Chordwise circulation at $r/R = 0.9$ produces the relative displacement of the incident vortex seen in the bottom view.

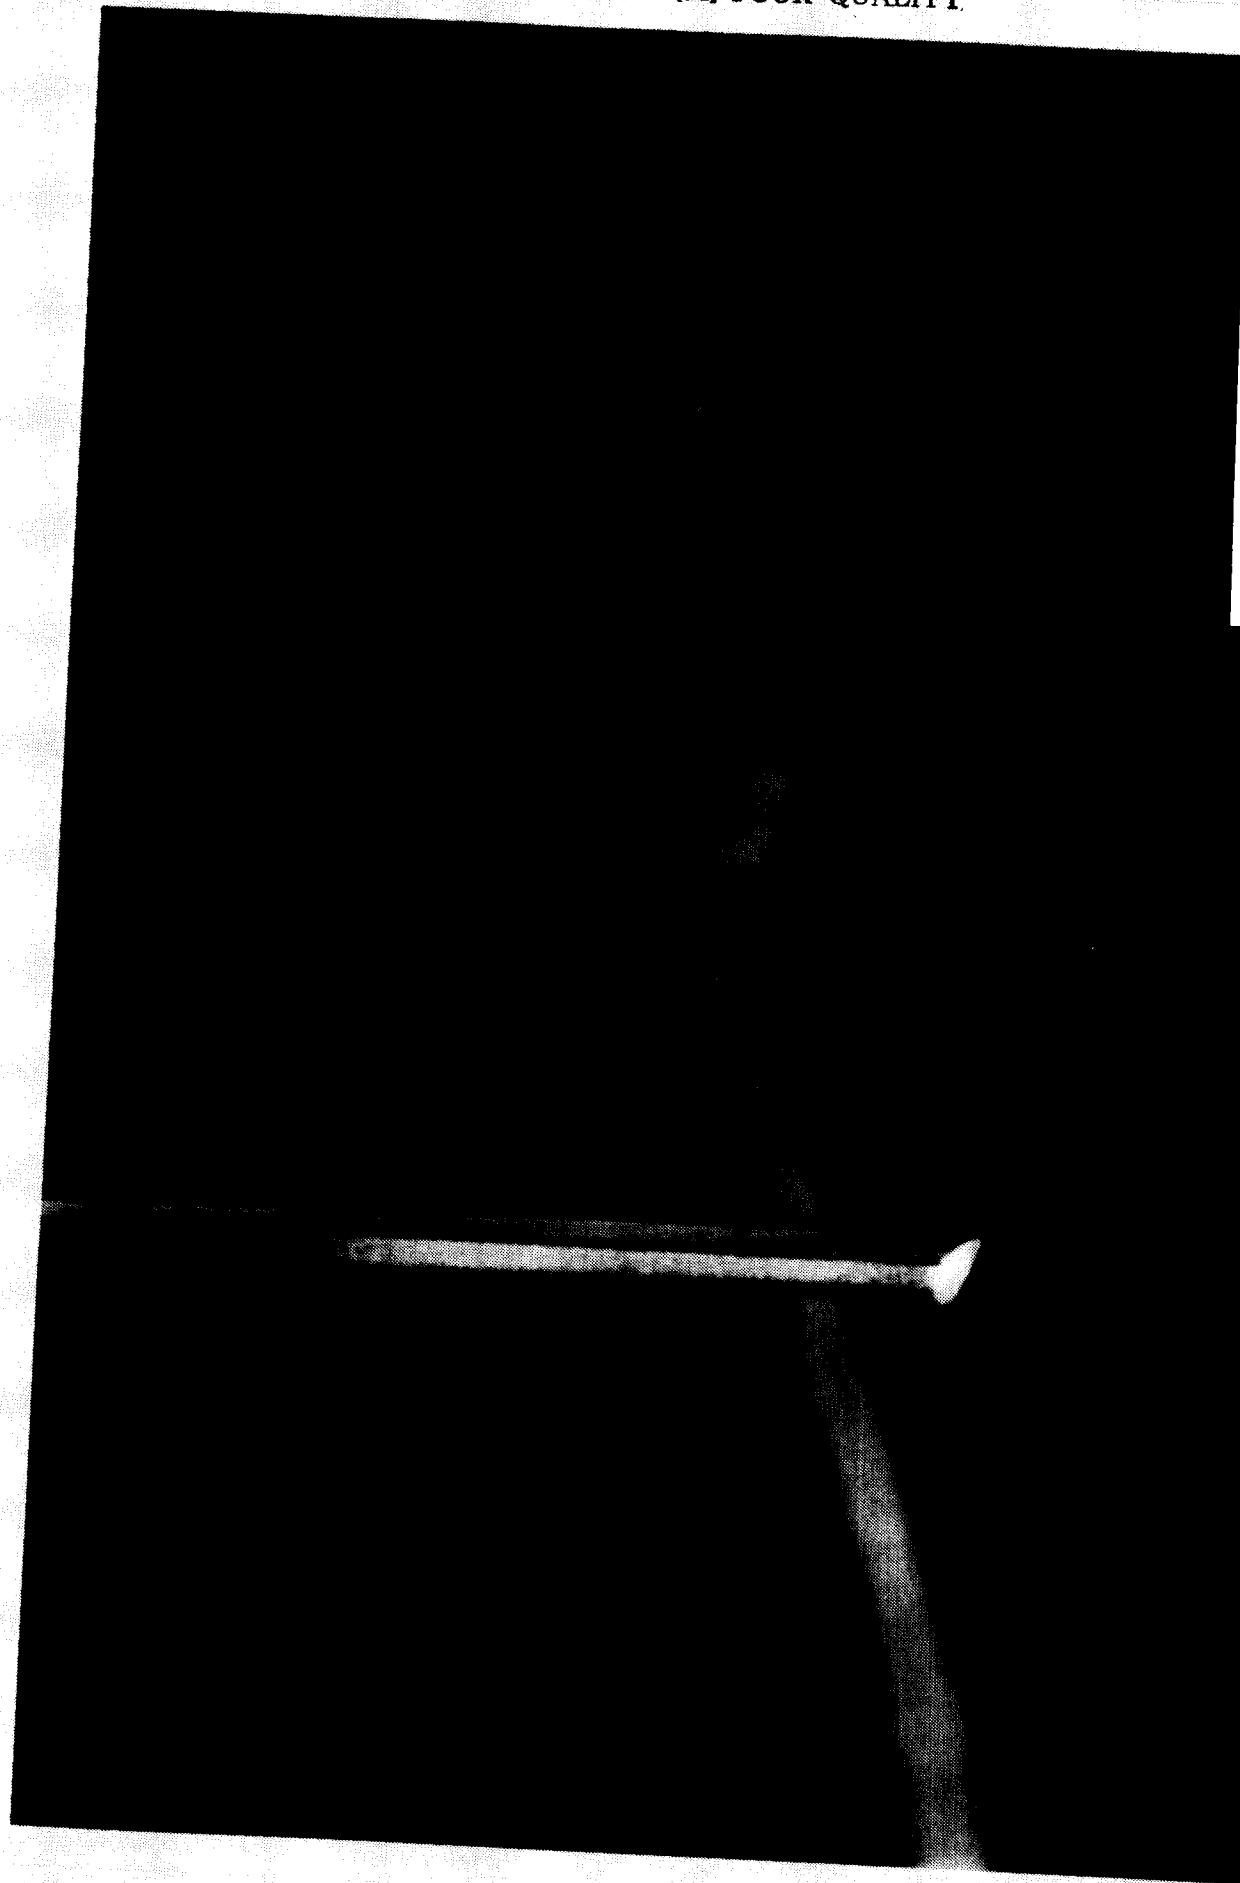
Fig. 5f: BVI at 15°, Side View

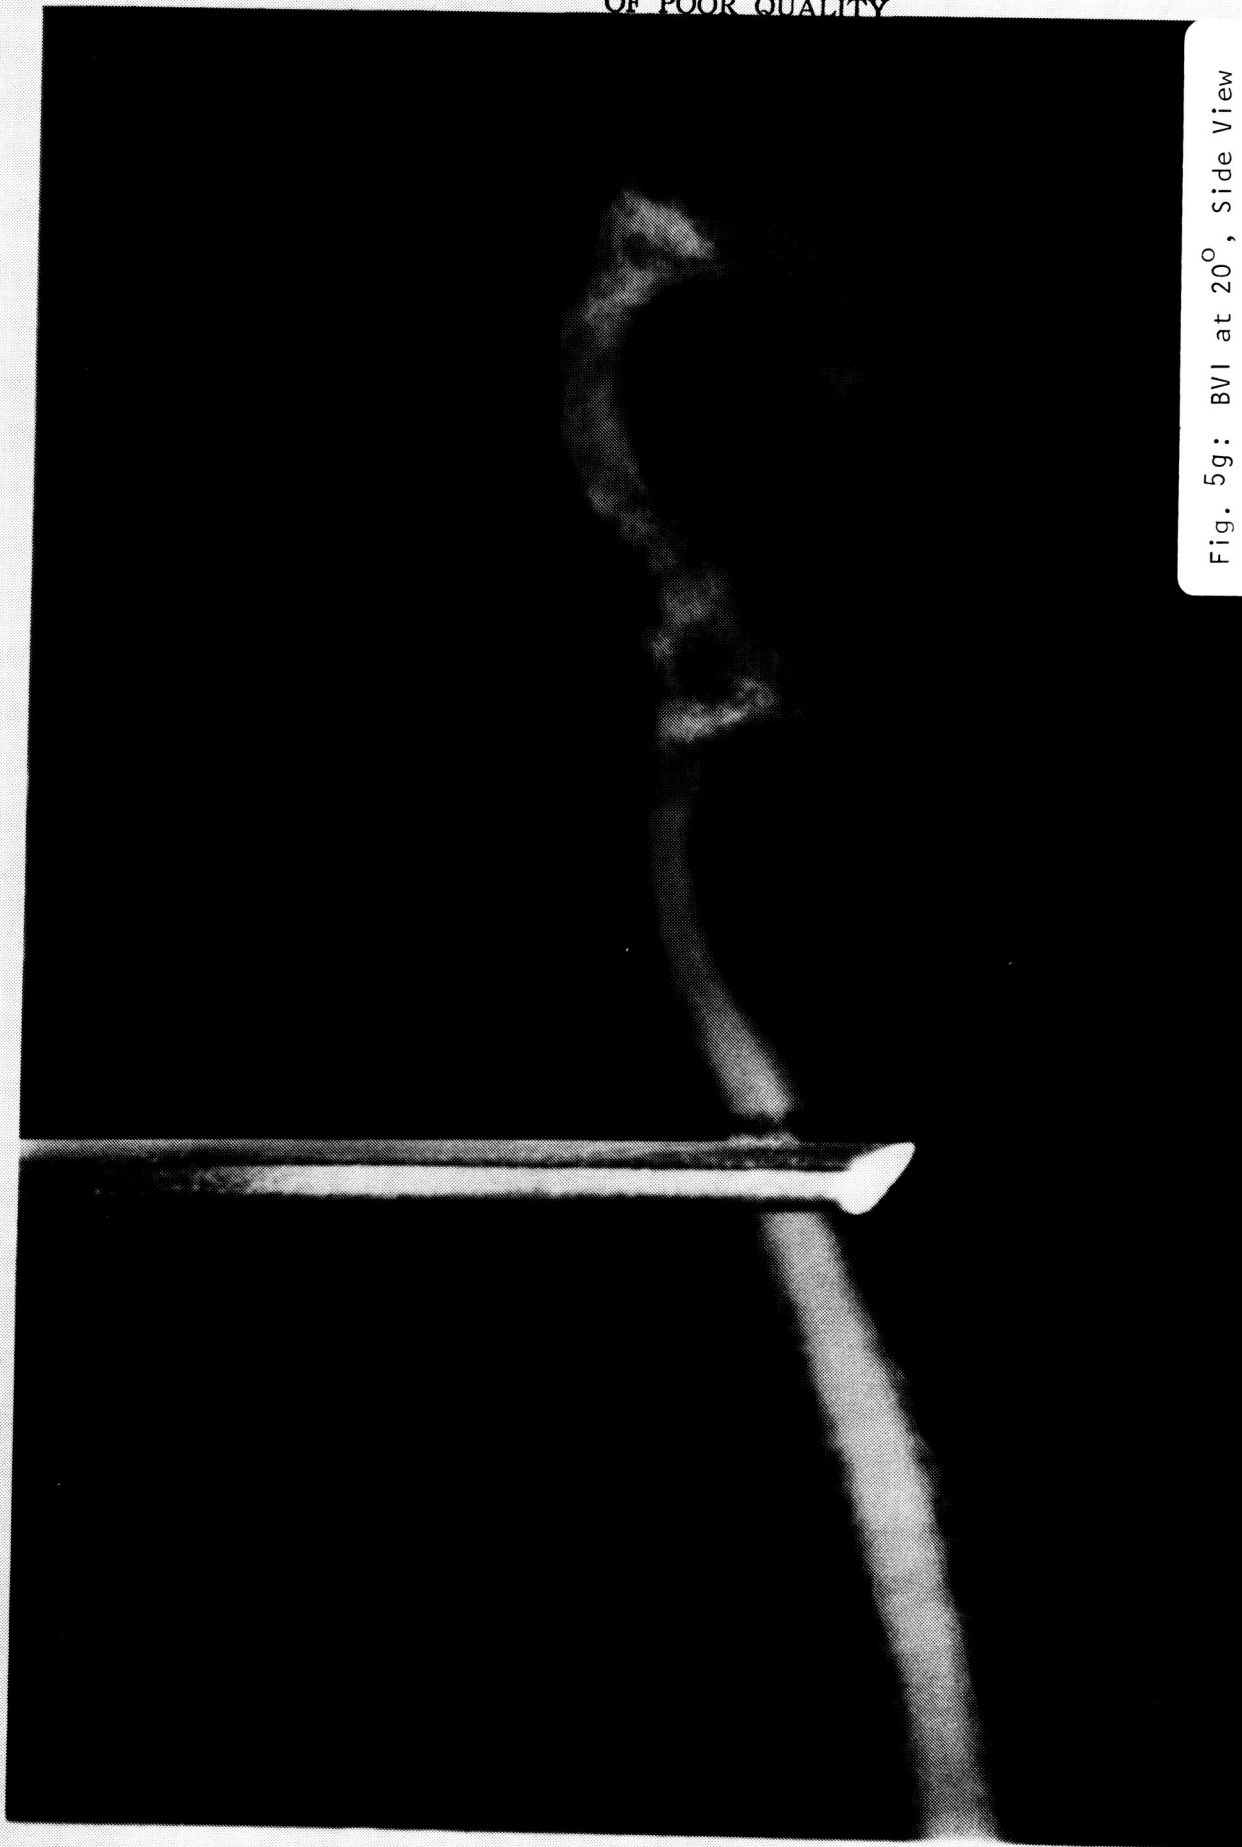
Fig. 5g: BVI at 20° , side View

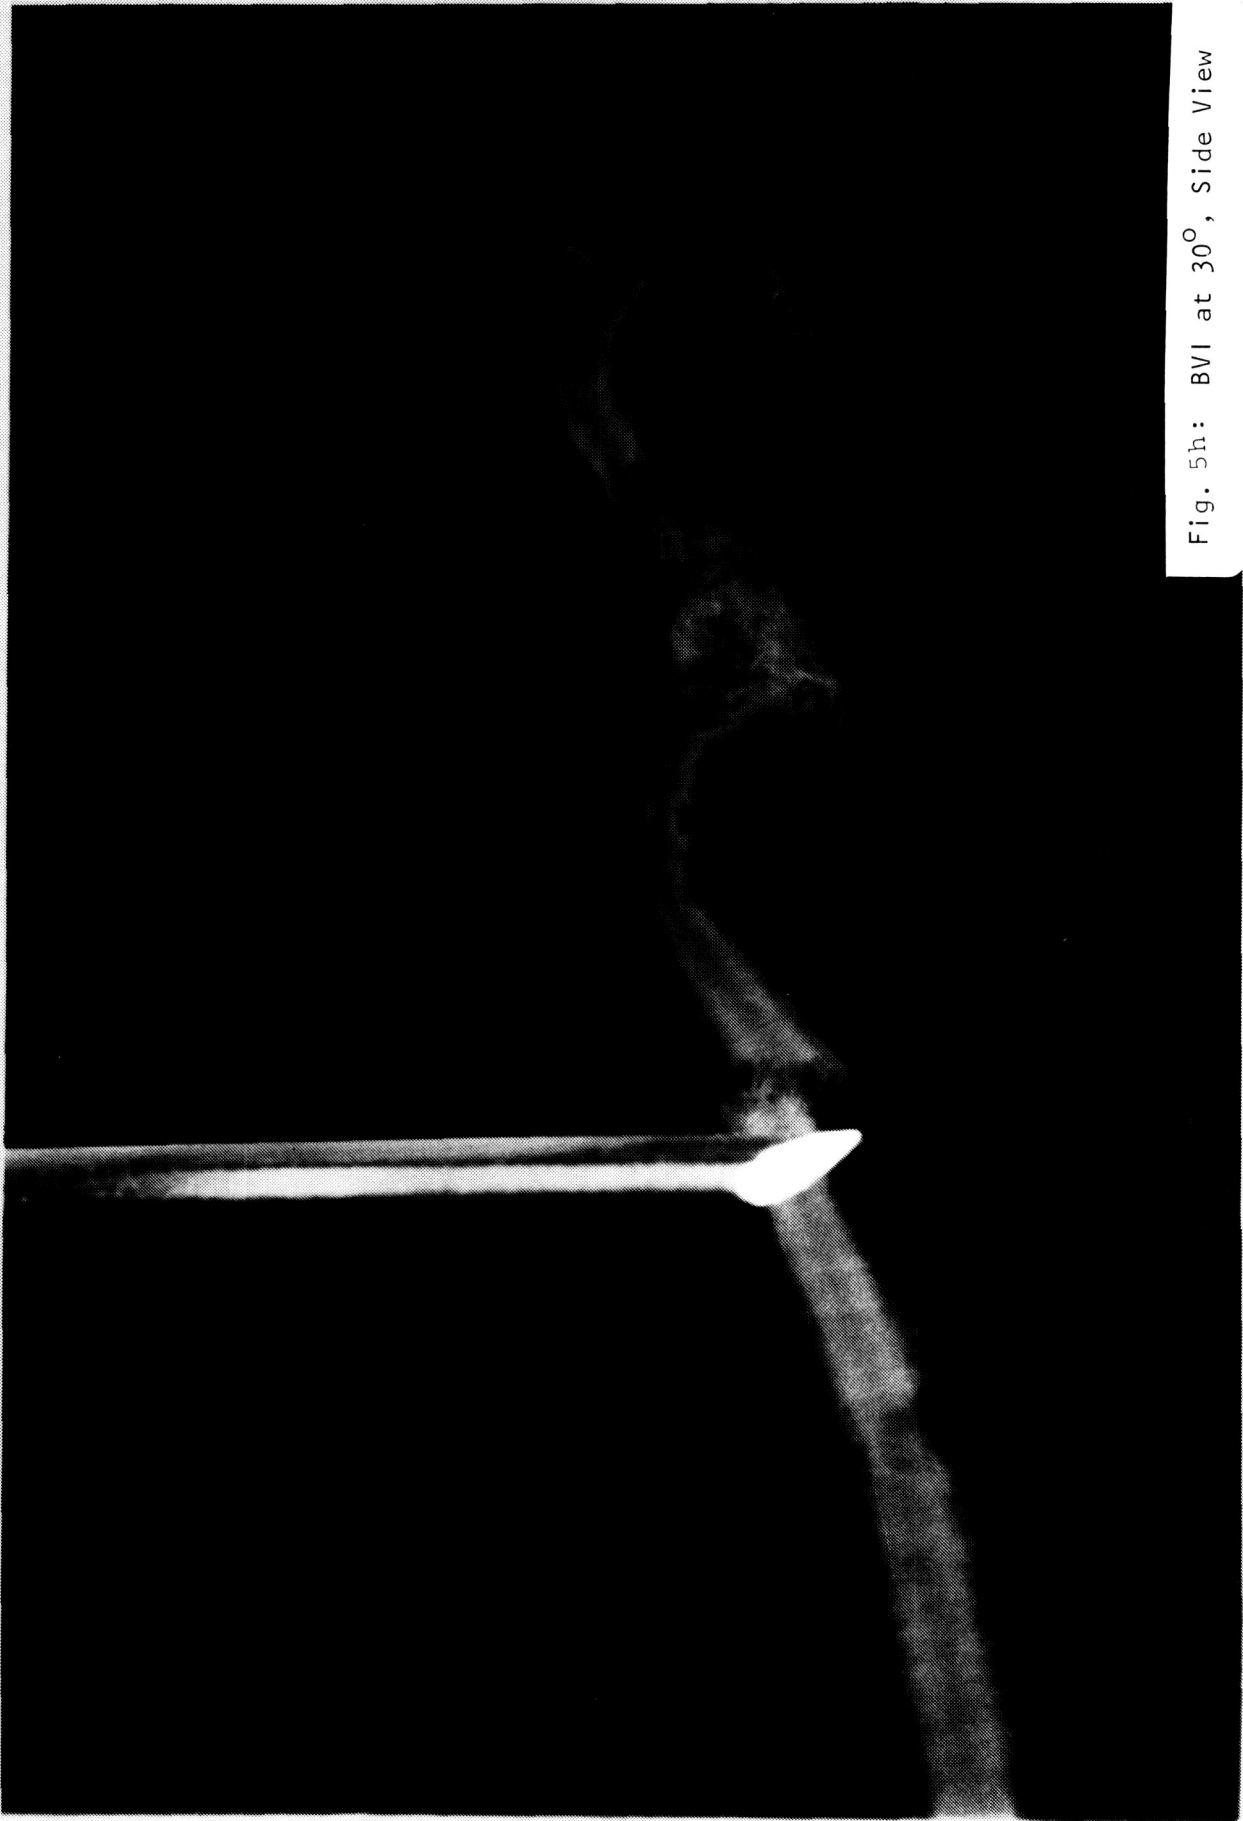
Fig. 5h: BVI at 30° , Side View

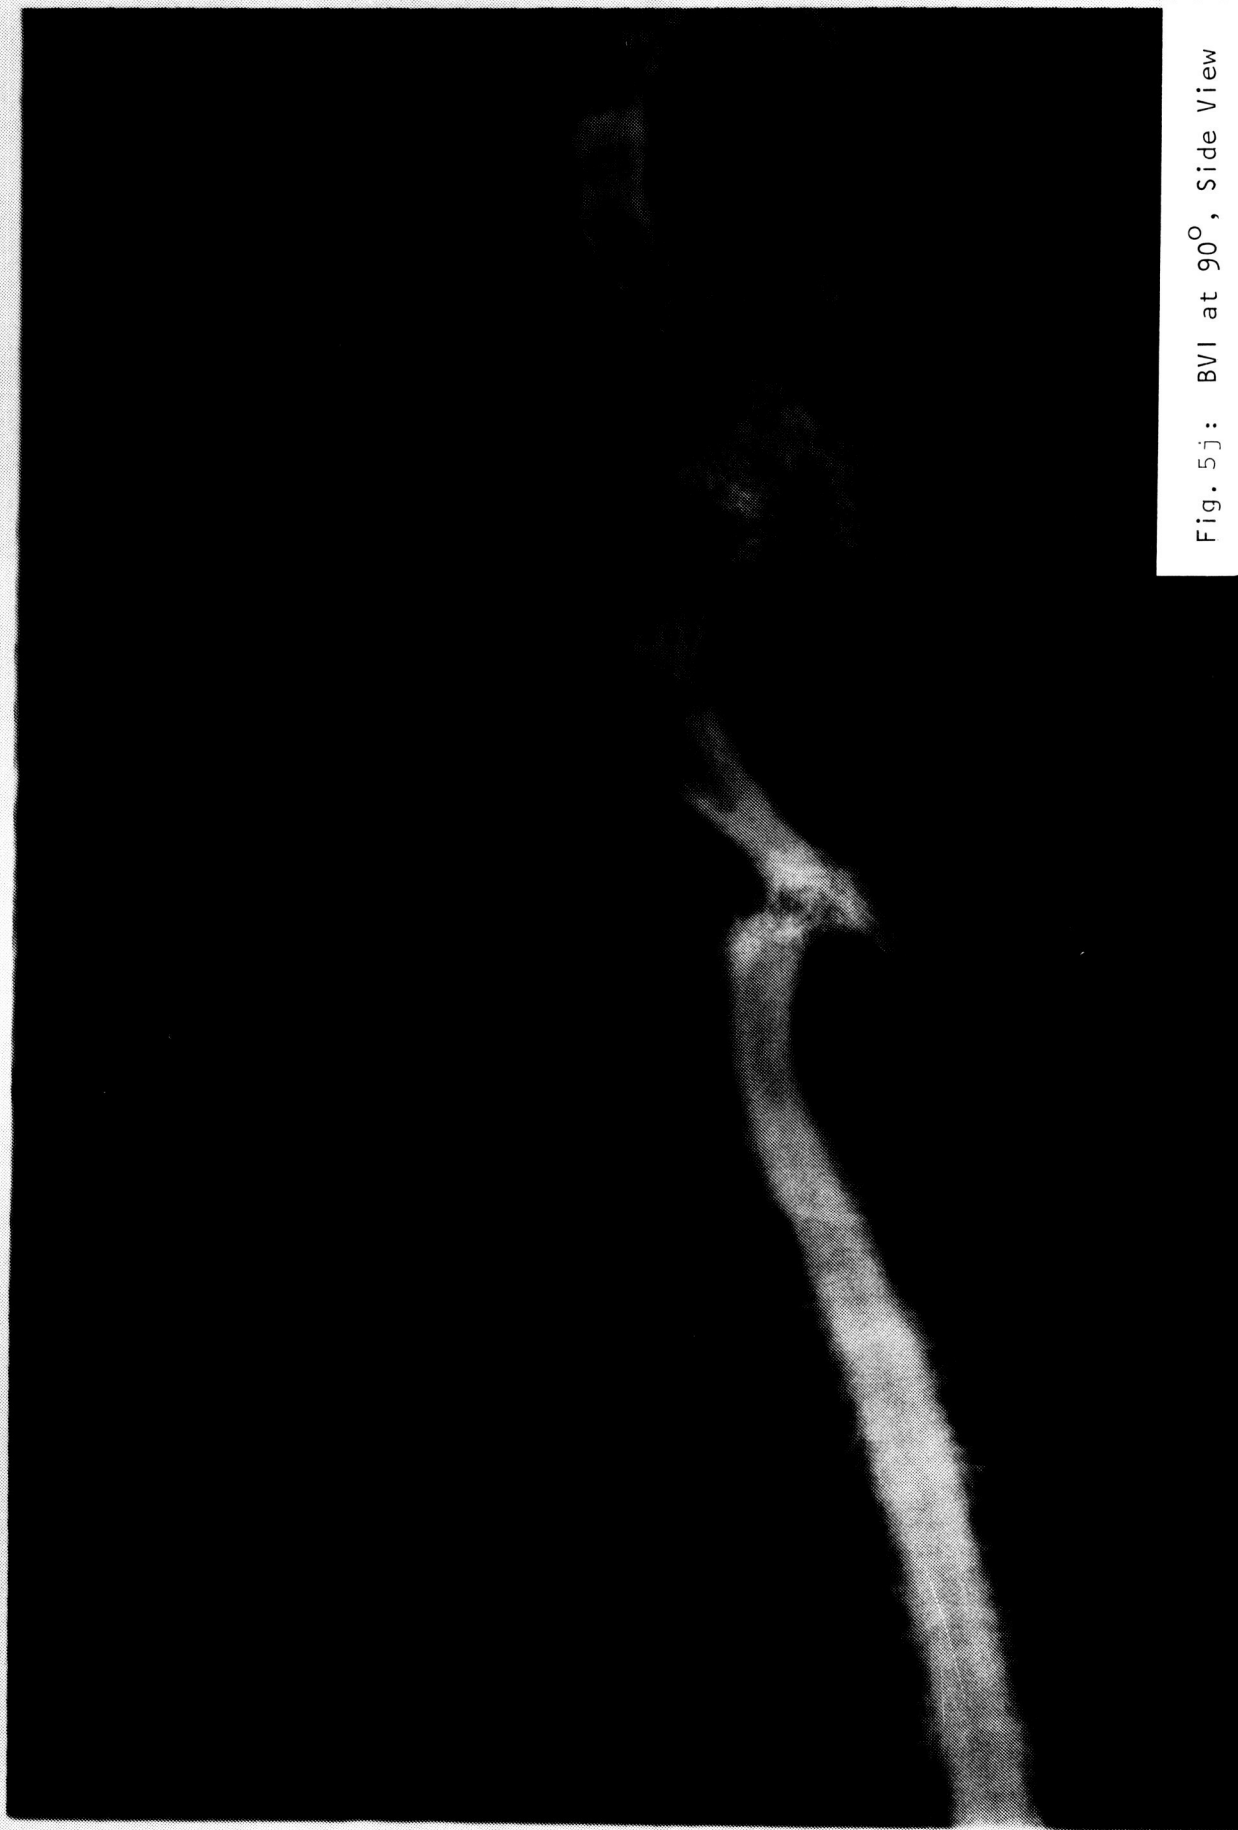
Fig. 5j: BVI at 90°, Side View

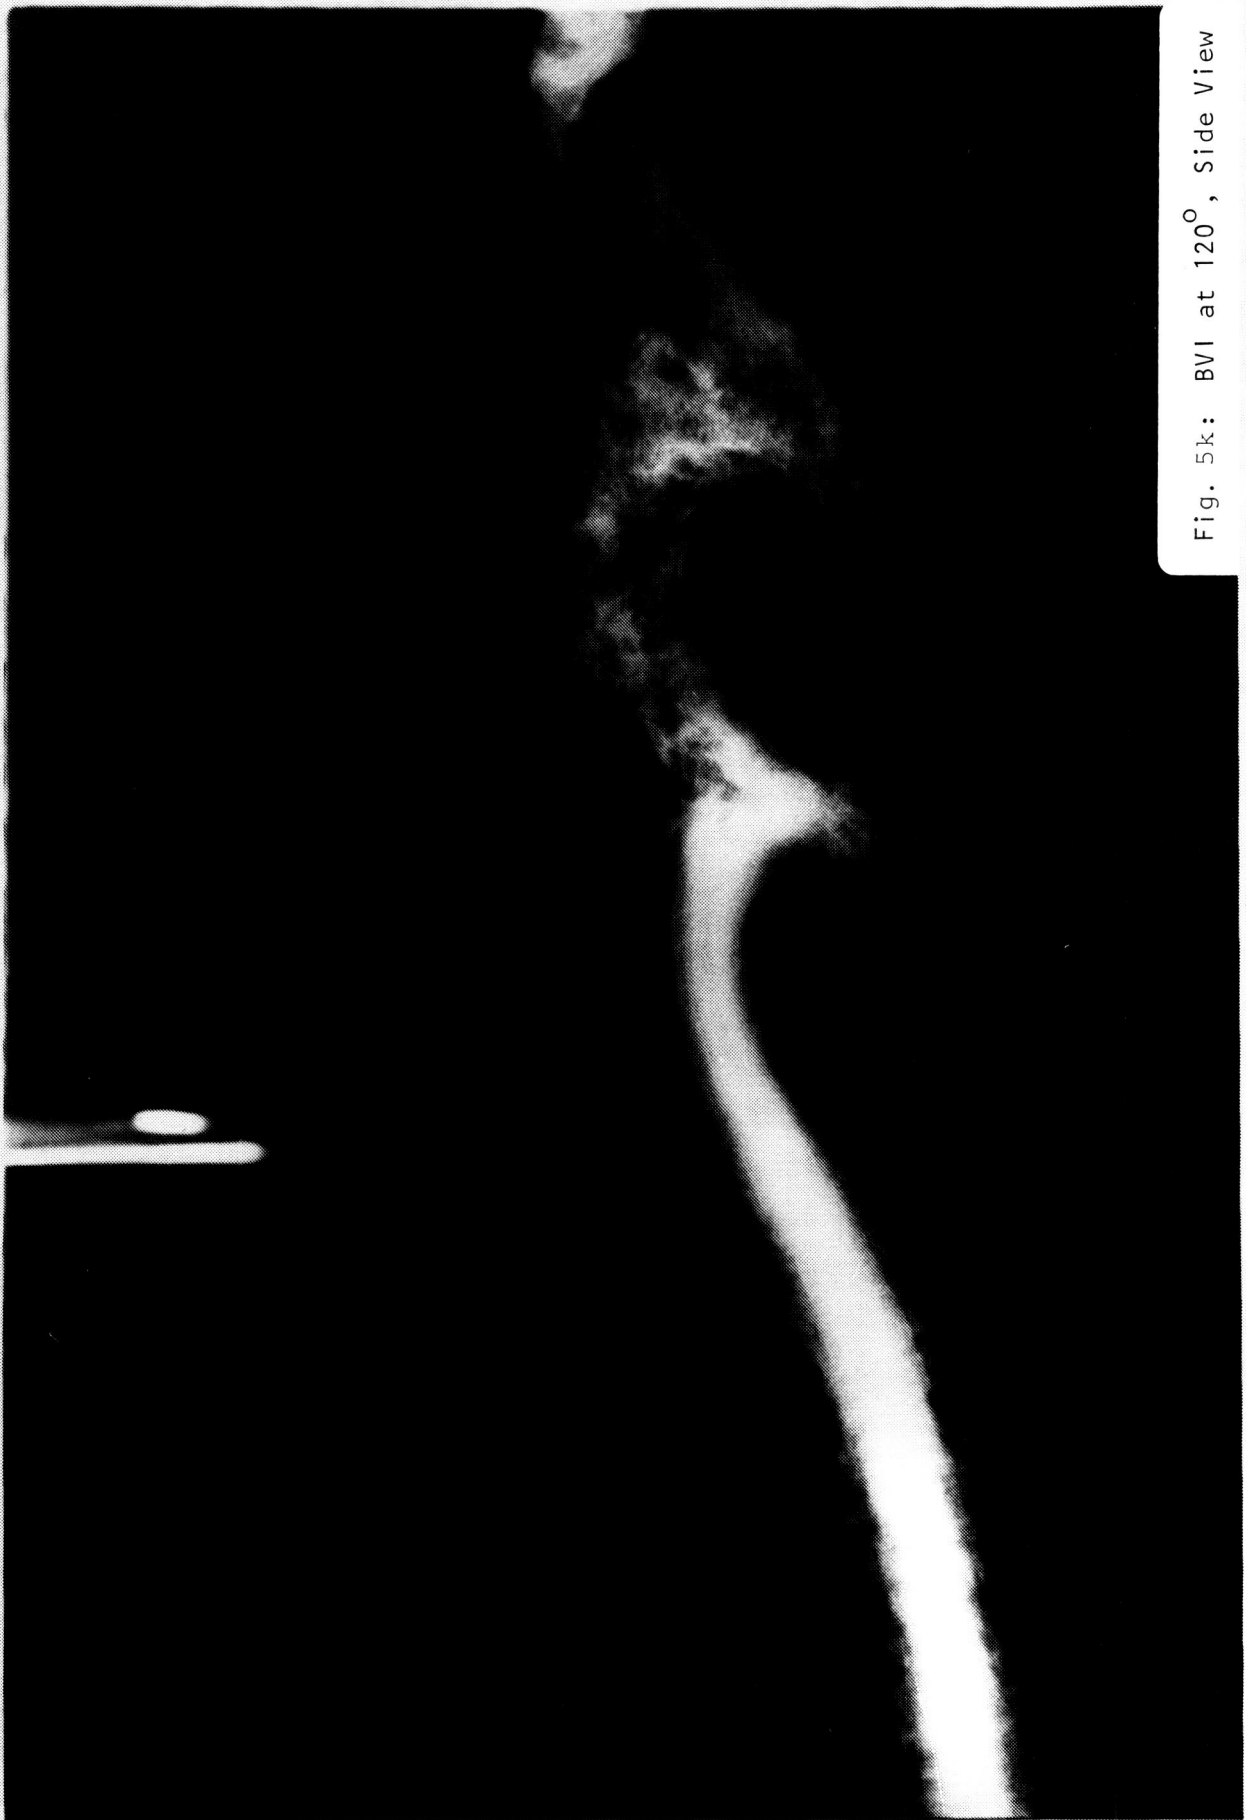
Fig. 5k: BVI at 120°, Side View
